Manhole Inspection Summary

Manhole # S49I__014MH

Location Address: **514 S ROSE-MILTON-ALLEY** Cross Street: **EASTERN-FLEET-ALLEY**

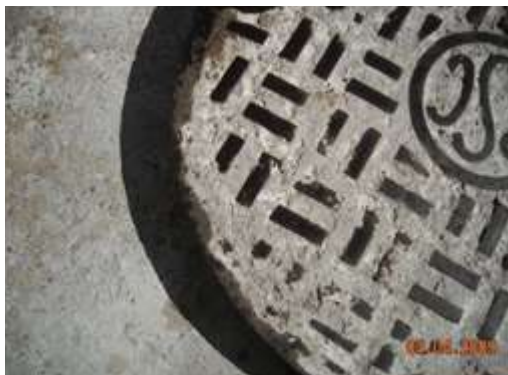
MISC.

Comments **USED 16LB MAUL, VINEGAR, AND SPRAY LUBRICANT TO FORCE OPEN MANHOLE COVER; FRAME AND COVER WAS SEALED BY CONCRETE (see photos)**

CONCRETE SEALED COVER TO
FRAME

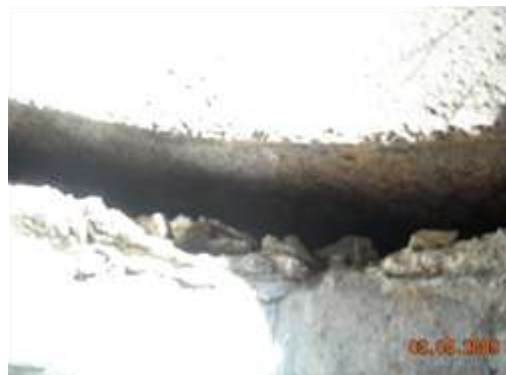
Defect 6

Chimney / Frame Adjustment ☒ Exists Material: **Brick** ☐ Parged Height: **3** (in.)
Condition: ☐ Sound ☒ **Cracked** ☐ Root Intrusion ☒ **Loose Brick** ☒ **Deteriorated**
Infiltration: ☐ None ☒ **Joint** ☐ Cracks ☐ Mortar ☐ Roots ☐ Wall

DETERIORATED CHIMNEY BRICKS

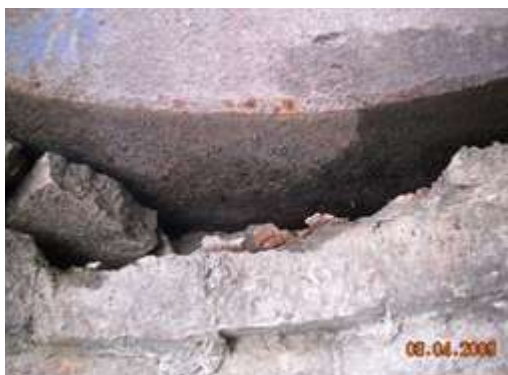
Defect 5

CRACKED CHIMNEY BRICKS

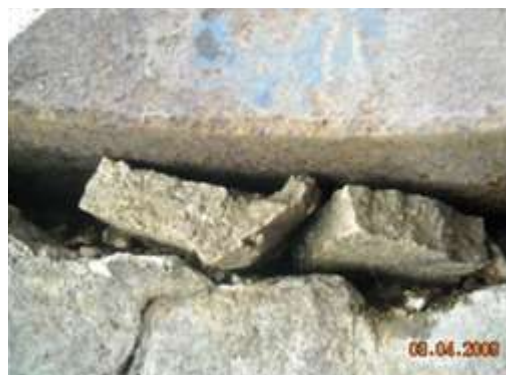
Defect 4

LOOSE CHIMNEY BRICK MATERIAL

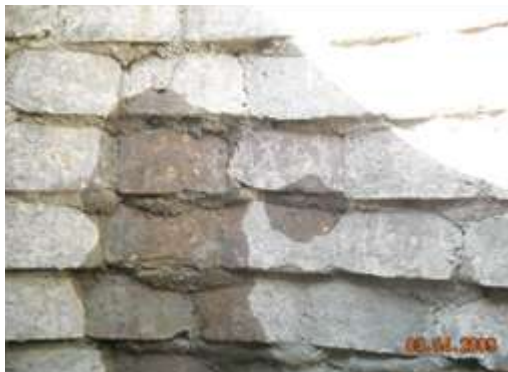
Defect 3

Corbel Material: **Brick** ☐ Parged Type: **Concentric/Eccentric**
Condition: ☒ Sound ☐ Cracked ☐ Root Intrusion ☐ Loose Brick ☐ Deteriorated
Infiltration: ☐ None ☐ Joint ☐ Cracks ☐ Mortar ☐ Roots ☒ **Wall**

INFILTRATION @ CORBEL WALL

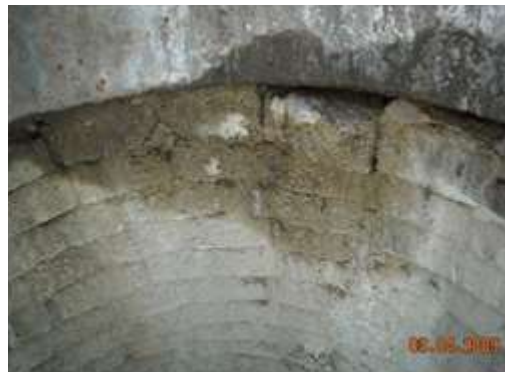
Defect 2

INFILTRATION @ CHIMNEY/FRAME
JOINT

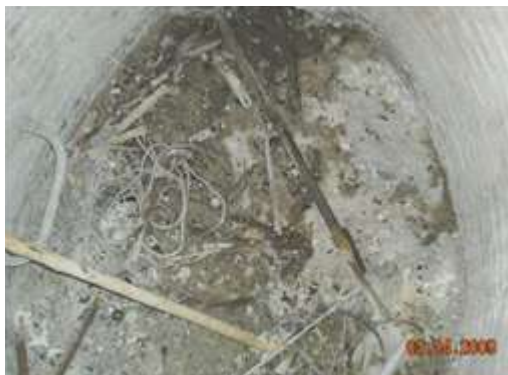
Defect 1

Channel Material: **Unknown** ☐ Parged
Channel Exposure: **Fully Open** Junc Dist: **0** nearest .5 ft. Azimuth: **0**
Condition: ☐ Sound ☐ Cracked ☐ Root Intrusion ☐ Deteriorated ☐ Leaks ☒ **Debris**

DEBRIS IN TERMINAL CHANNEL

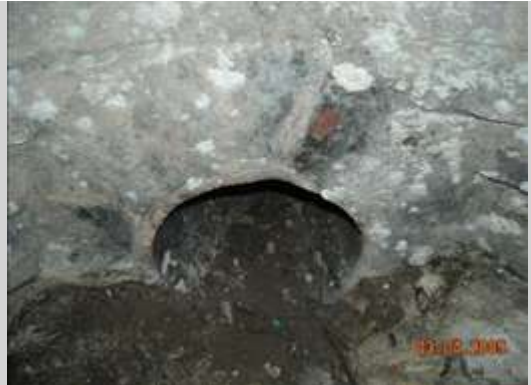
12 O'Clock Outflow

8 in. Circular Gravity Sewer
Pipe Out @ 12 O'Clock

Deposits: ☐ None ☒ **Mud** ☐ Sludge ☐ Debris ☐ Grease

Silt Depth: **1** (in.) Deposits Extent: **Light**
